December 2024

漁農自然護理署
Agriculture, Fisheries and
Conservation Department

Challenges Along the Journey (Part 1)

Natural Trail Degradation

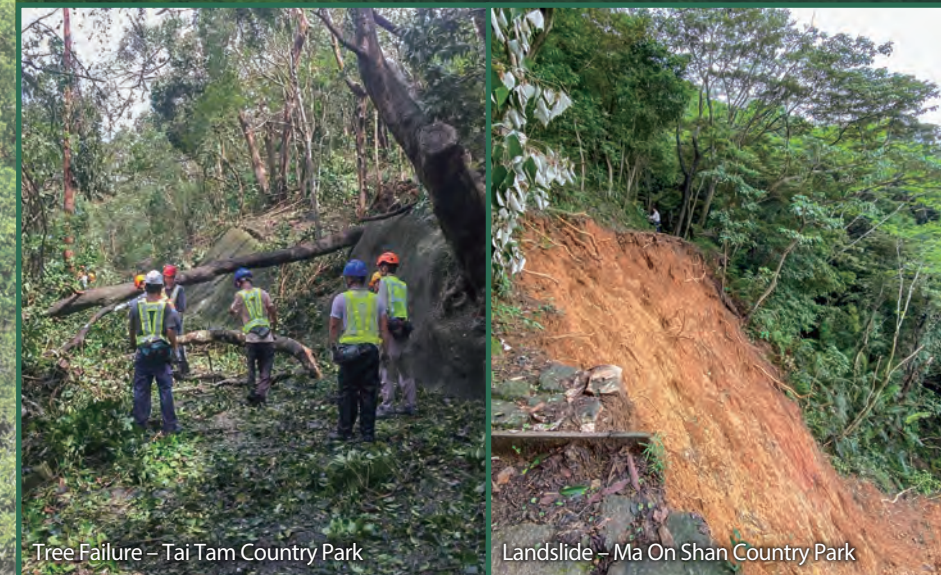
Tree Failure – Tai Tam Country Park

Landslide – Ma On Shan Country Park

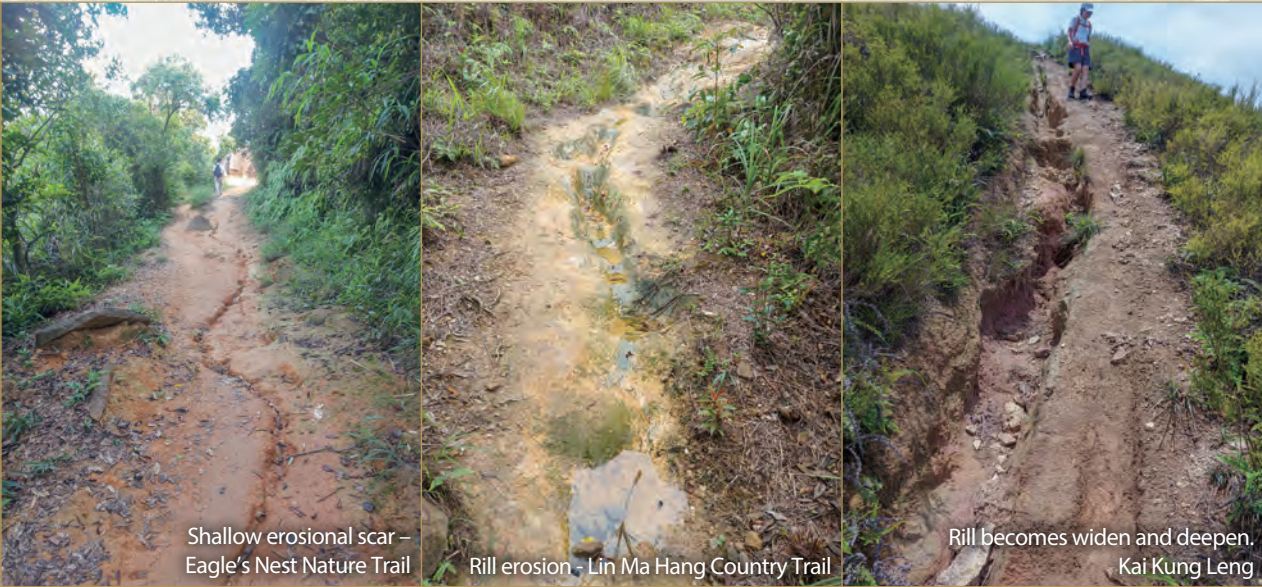
a. Rills and Gullies

When the rate of rainfall exceeds the rate of soil infiltration, surface runoff occurs. It erodes the topsoil and creates shallow rills on the trails. These rills deepen and widen with repeated erosion process. As trail tread conditions deteriorate, visitors may be discouraged from staying on the designated trail treads. Instead, they may trample surrounding vegetation in an attempt to navigate around the undesirable trail conditions. The underlying soil may be exposed to the air and become susceptible to further erosion. When the topsoil is eroded, it can lead to bedrock exposure.

When visitors perceive potential risks while hiking on designated trails, they may trample the vegetation along the trailside. This can lead to the exposure of underlying soil as the vegetation diminishes.

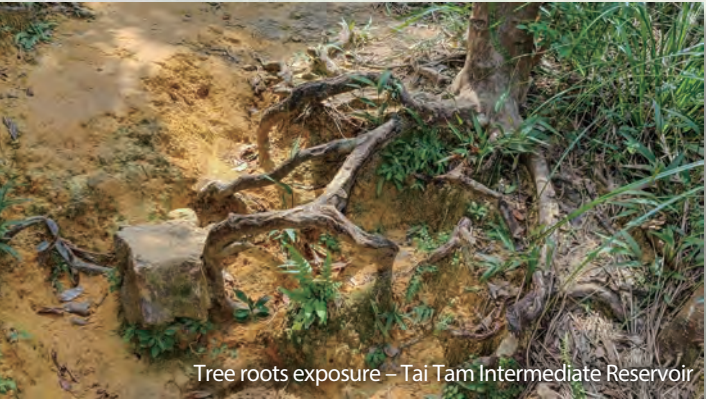
c. Tree Roots Exposure

Rainwater can also impact the surrounding natural environment by eroding the topsoil and exposing tree roots that were previously protected by soil. Such exposure hinders the vegetation growth, destabilises the tree's root system and impairs nutrient absorption. It ultimately affects overall health of the nearby vegetation. In severe cases, it can lead to tree mortality or failure. Furthermore, exposed roots pose a safety risk for visitors, such as increasing the risk of trips and falls.

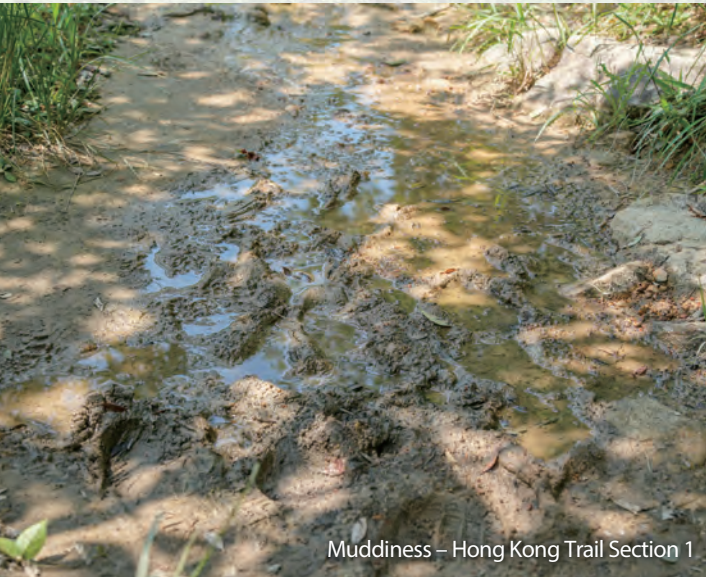
2. Muddiness and Standing Water

Light rainfall can make rock surfaces slippery. When rainfall increases, rainwater mixes with soil and create muddy conditions on the trails. This phenomenon is influenced by local geology and soil structure, particularly clay-rich soils with smaller pores that hinder rainwater drainage and reduce the infiltration rate. In some cases, water may even pool on the trails for several days.

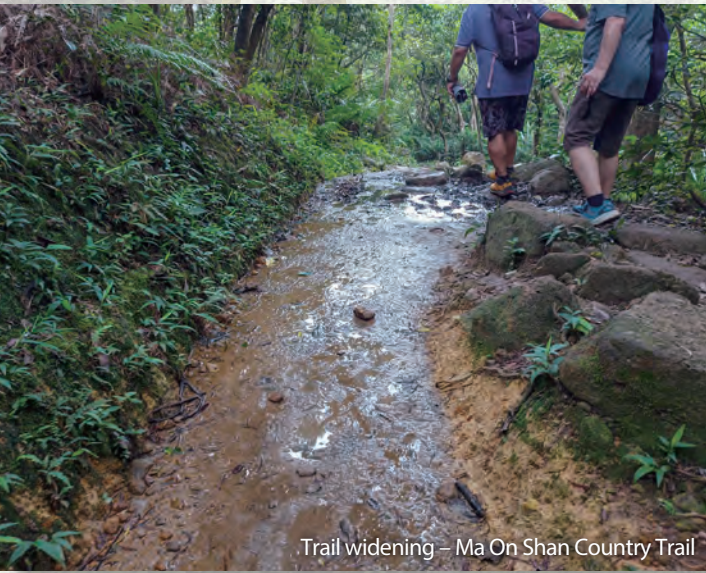
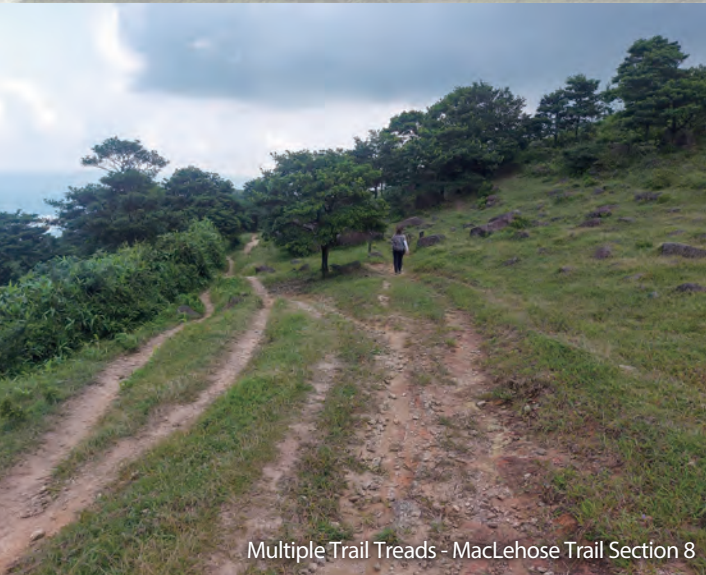
3. Visitors' Behaviours

The overall trail condition deteriorates when erosion, flooding, muddiness, and exposed tree roots appear on the trail treads. This deterioration can compromise visitors' safety and comfort while navigating the rugged trail conditions. It can also influence how visitor behave on the trails, which could further exacerbate existing trail problems.

For instance, visitors may trample surrounding vegetation or create informal paths to navigate around rugged trail sections. When vegetation is damaged due to trampling, the underlying soil becomes exposed and more susceptible to erosion. This exacerbates soil loss and initiates a vicious cycle, making restoration increasingly difficult and threatening the integrity of the natural environment. The trail impacts related to visitors' behaviours and usage will be discuss in the next Newsletter.

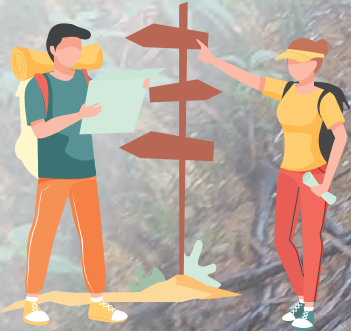
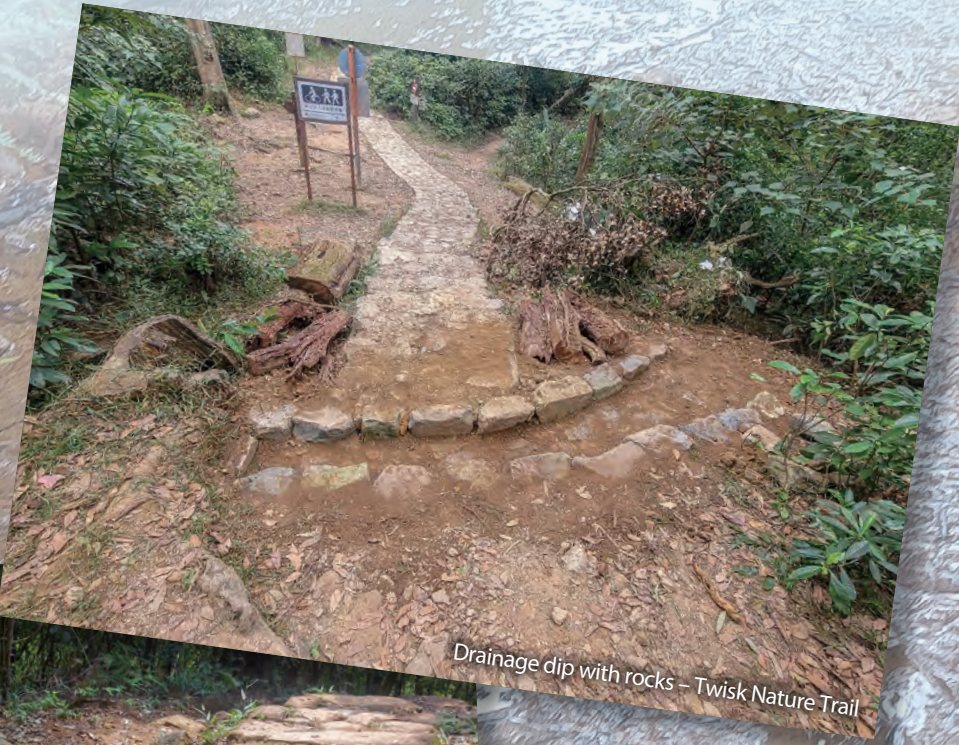
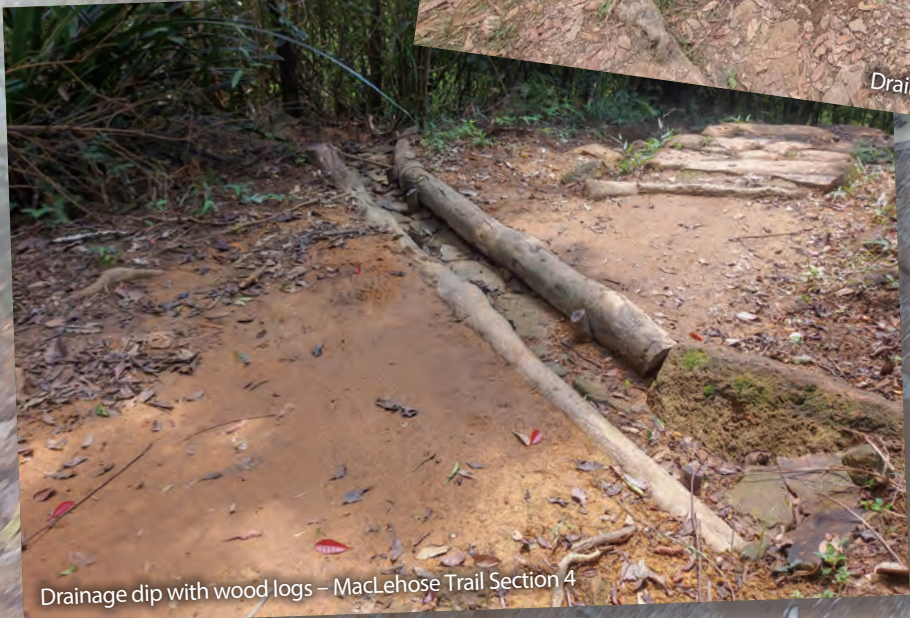
Prevention: Drainage Facilities to Mitigate Erosion Effects

To mitigate the erosive effects of rainwater and runoff on the trails, thoughtful trail designs and effective drainage facilities are incorporated during trail construction as a proactive measure. The two fundamental principles for effectively draining excess water from the trail are: water naturally flows from higher to lower ground, and the use of natural features, such as trees and large rocks, to redirect water flow. AFCD trail building masters need to observe the local topography thoroughly, and then determine the best locations for constructing drainage facilities and making necessary slope adjustments to mitigate the impacts of rainwater and runoff.

The major purpose of trail drainage facilities is to quickly channel rainwater away from the trail. They can reduce the impacts of rainwater and runoff on the trail surface, and also prevent water accumulation that can lead to pooling or muddy conditions. By efficiently draining rainwater, we can keep the trails safe and walkable. It can ensure the safety of visitors while minimising the damages to the surrounding environment.

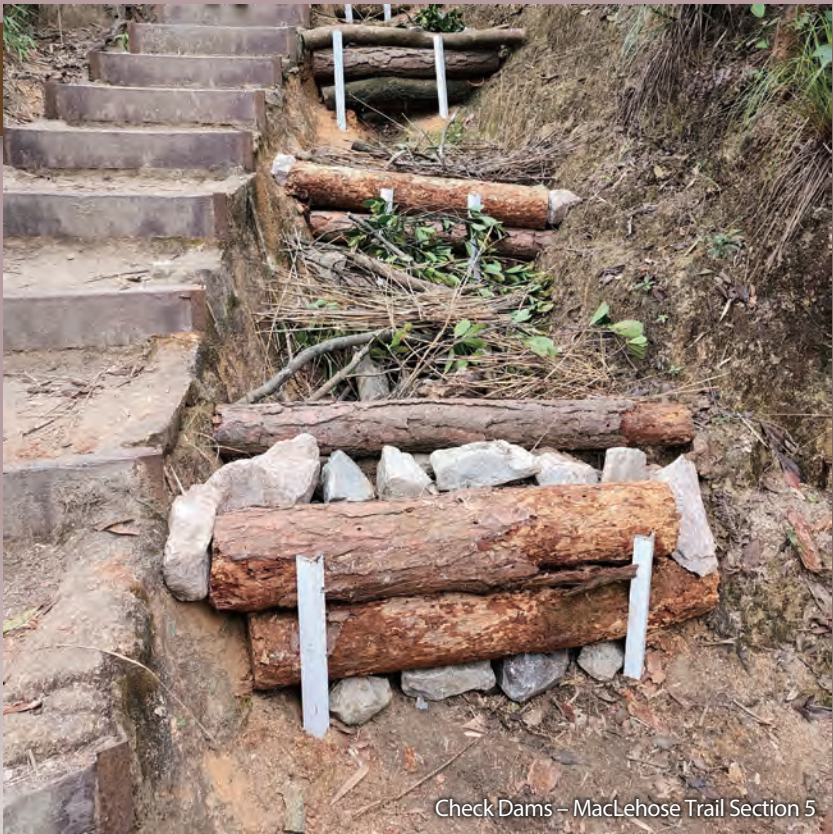
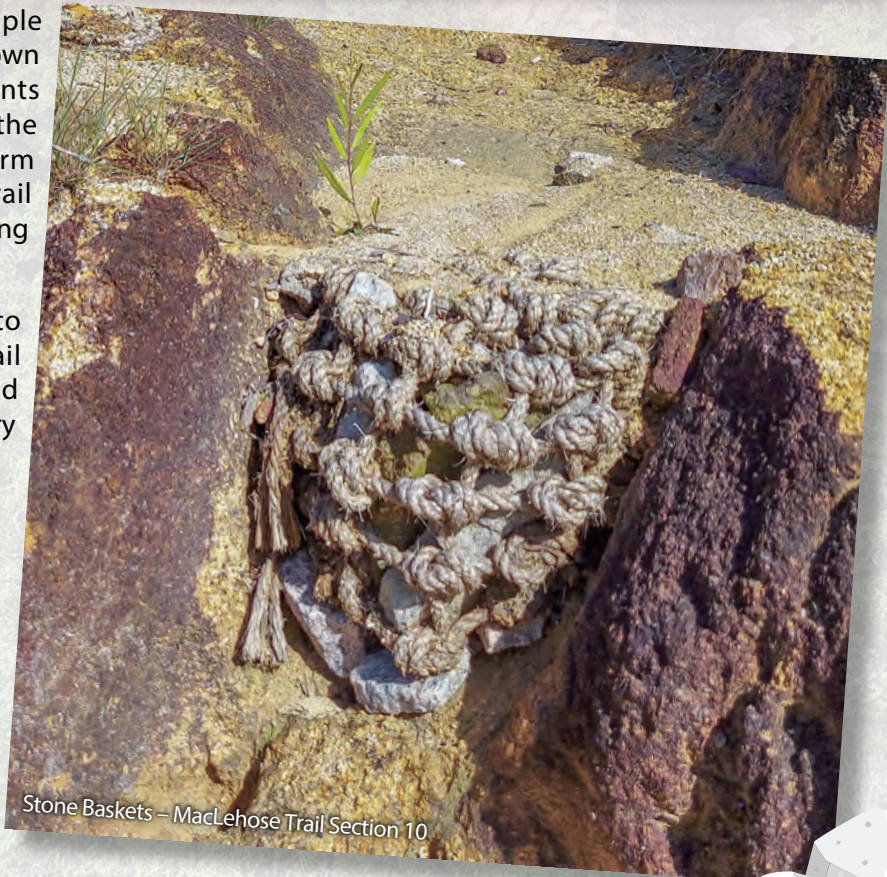
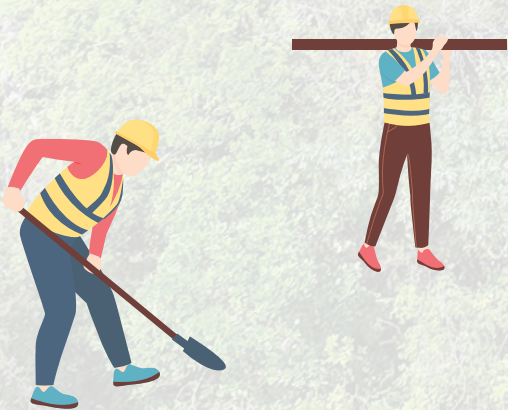
Restoration: Repair Eroded Trails to Restore Trail Environment

Following heavy rainfall events, AFCD frontline staff inspect the trails in country parks and conduct risk assessments. For trails with minor damages, the maintenance team performs simple repairing works, such as clear debris and fallen tree branches. However, if the severe damage is observed or there is a significant risk of further collapse, the trail will be temporarily closed for slope stabilisation or large-scale trail maintenance works.

The maintenance team also employs some restoration techniques in areas suffering from serious erosion, such as check dams, stone baskets, and stone works for root protection. The fundamental principle behind these techniques is to slow down the water flow and capture sediments eroded from the uphill. Over time, the sediments can form a stable platform that can be used as a part of the trail tread surface or as an area for planting vegetation.

These restoration techniques aim to restore the eroded or degraded trail sections, enhance trail appearance and conditions, and facilitate the recovery of the degraded natural landscape.

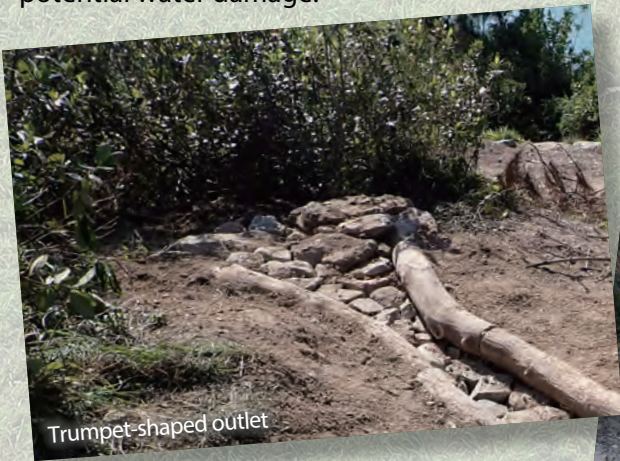
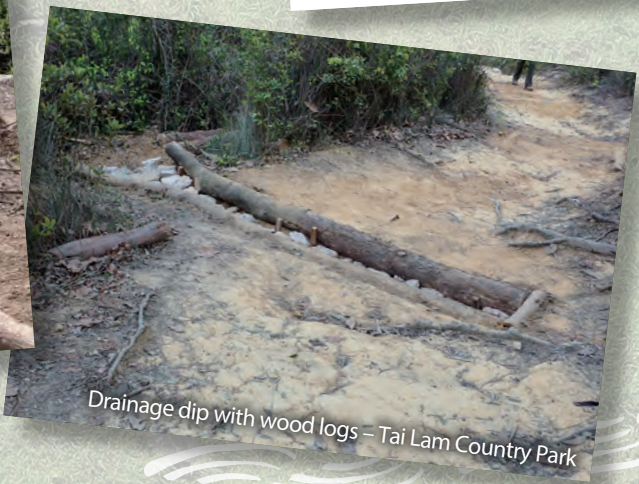
1. Drainage Dip

This design is particularly suitable for flatter sections of the trail. It involves creating a sunken drainage channel that runs across the trail, which allows surface rainwater to flow in and collect, thereby directing it away from the trail.

In certain situations, it may be necessary to place stones at the bottom of the channels and create a trumpet-shaped drainage outlet. Adding energy-dissipating stones at the outlet helps disperse water energy onto more resilient surfaces. These features can effectively protect both the trail and drainage structure from potential water damage.

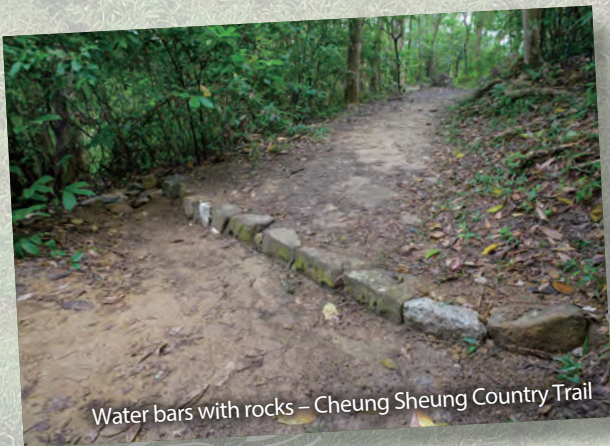
2. Water Bars

Placing hard natural materials, such as wood logs or stones on the trail surface, can effectively redirect rainwater. As water flows on trail surface and encounters a water bar, its direction changes and guide it off the trail. This design is applicable for both flatter and steeper sections of the trail.

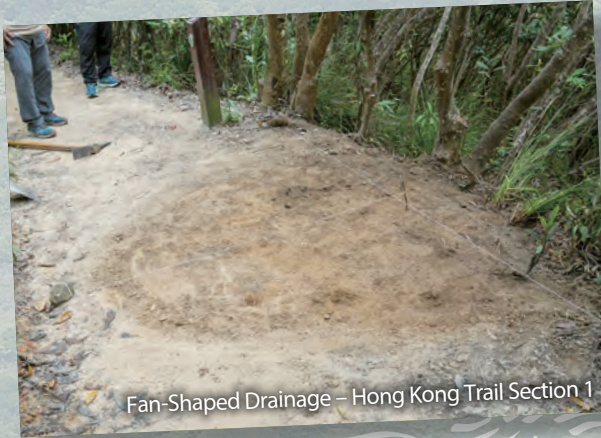
3. Fan-Shaped Drainage

Leveraging the principle of gravity, fan-shaped drainage systems are designed to create a low point at the downhill slope of the trail. This design effectively directs rainwater away from the surface, so as to prevent rainwater from pooling and mitigate the trail problems of muddiness and erosion.

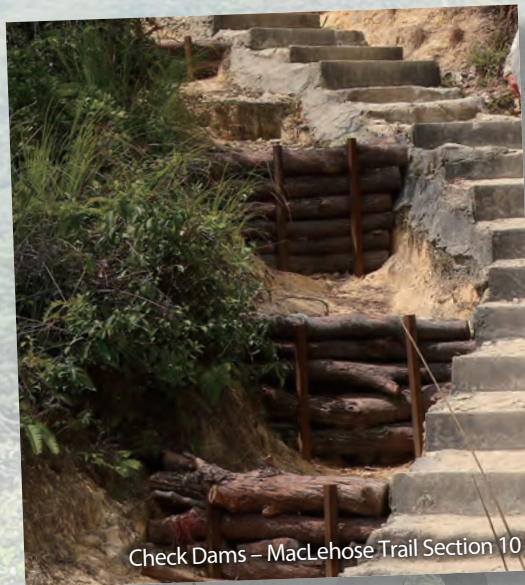
1. Check Dams

By placing wood logs, stones and or steel angles in areas where the trail has experienced severe erosion, they can slow down rainwater flow and mitigate the erosive effect of surface runoff. This design helps intercept sediment being washed down and facilitate the deposition of sediment, thereby form a stable platform behind the check dam that can be utilized for vegetation planting and as part of the trail tread.

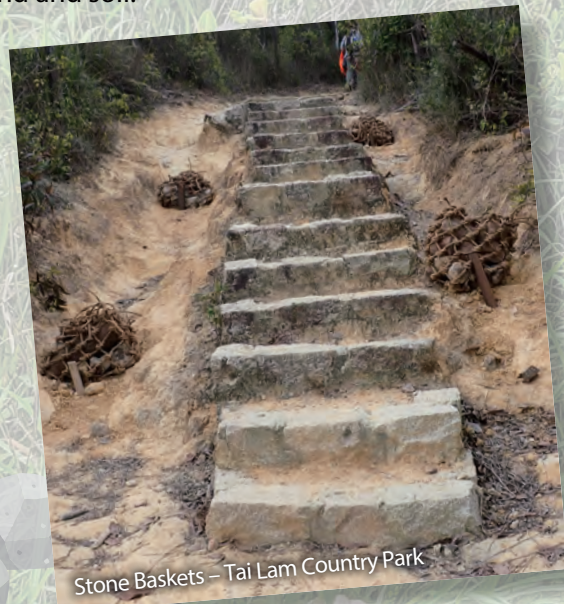
2. Stone Baskets

This method is similar to the check dam approach but it is more suitable for trail sections that have experienced lighter soil loss along the tread. The size of the stone baskets can be adjusted based on the depth of the erosional scars.

After being in place for some time, these stone baskets assist with soil and stone backfilling. The bags themselves naturally decompose, ultimately leaving behind stones that are stabilised by the accumulated sand and soil.

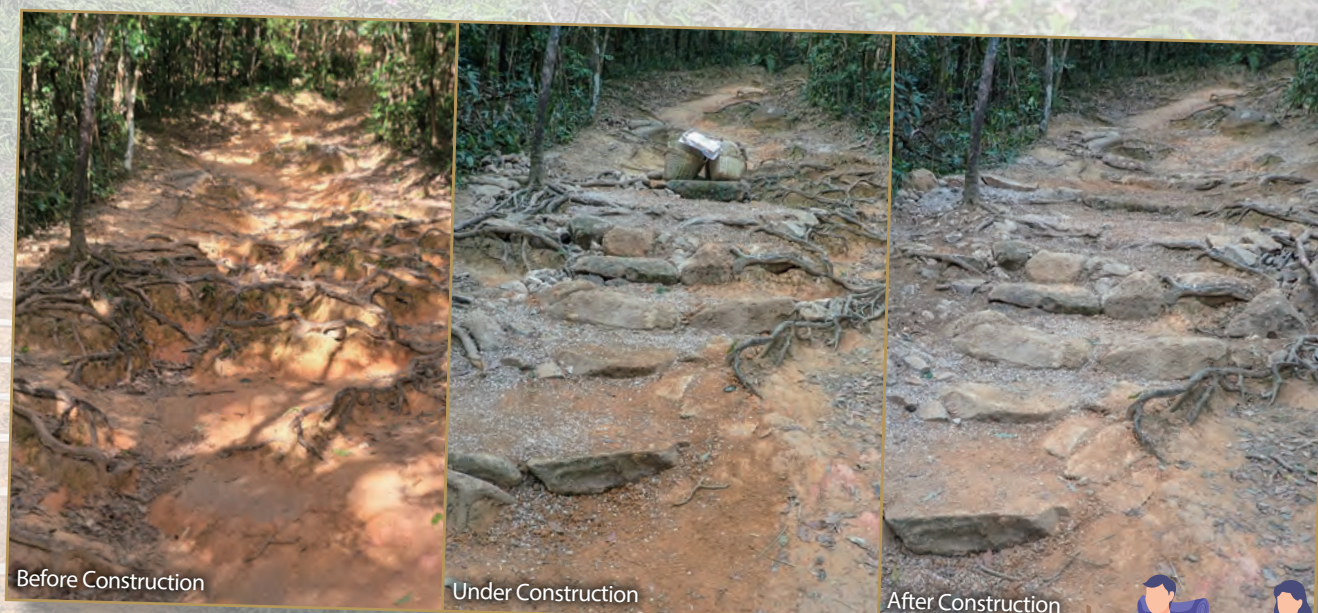
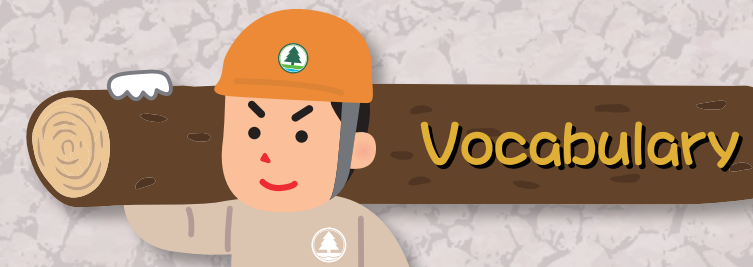
3. Stone Works for Root Protection

This design involves placing large stones on the uphill side, closely adjacent to exposed tree roots, with a height of approximately 0.5 to 1 inch above the roots, creating stone steps. Suitable-sized stones are then inserted into the gaps between the roots and the soil. This approach protects the exposed roots from trampling and enhances the overall stability of the trail.

Additionally, this design promotes the accumulation of sand and soil in the gaps between the stones, which allows the exposed roots to reconnect with the soil. This is beneficial for root development and the overall growth of the tree, while also enhancing the safety of visitors walking nearby.
